Assessment of a Post-Fire Debris Flow Impacting El Capitan Watershed, Santa Barbara County, California, U.S.A.

JONATHAN YONNI SCHWARTZ*

Minerals & Geology, Los Padres National Forest, U.S. Forest Service, 1190 East Ojai Avenue, Ojai, CA 93023

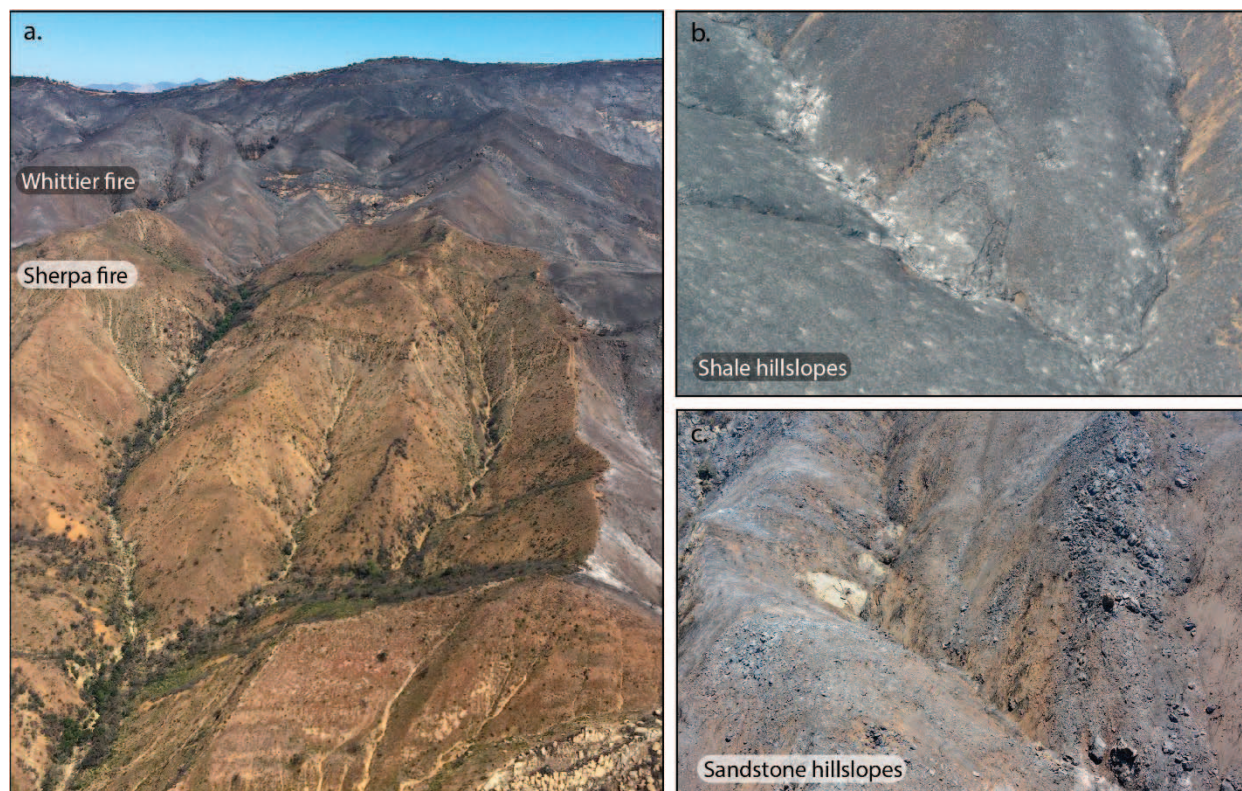
Since this post-debris flow investigation focused on the inundation zone, ground assessment and documentation were minimal in the source area. In the limited post-flooding field assessment of the upper portions of the impacted watersheds, rill development and surface erosion were noted on the slopes above the El Capitan Creek and its tributaries channels, but no detailed measurements were taken to document the extent of surface erosion and quantity material delivered from the source area. On 9 July 2017, 6 months after this flooding and debris flow event, the Whittier Fire ignited and burned on both the north and south facing slopes of the Santa Ynez Mountains, adjacent to and overlapping with portions of the Sherpa Fire. Aerial flight reconnaissance conducted during the BAER assessment of the Whittier Fire revealed widespread rilling and surface erosion throughout the steep burned slopes, especially in the shale units. Aerial photography shows the post-fire soil conditions for shale and sandstone units in the Whittier Fire burn area and reveal that many gullies and first-order channels in the Sherpa Fire burn area had been scoured to bedrock (Figure 6).

Figure 6. (a) Burned areas of the Sherpa and Whittier fires. This photo was taken a year after the Sherpa Fire, 6 months after the rainstorm and debris flow events, and 2 weeks after the Whittier Fire. Gullies and first-order channels in the Sherpa Fire burn area were scoured to bedrock (photo taken by Kevin Cooper, USFS). (b) Shale hillslopes mantled with thick, continuous fine-grained soil, ash, and charred organic matter. Vegetation is completely incinerated. (c) Sandstone hillslopes composed of thin, patchy soils; bedrock outcrop; ash; charred organic matter; and silt-rich colluvium with grain sizes up to boulders.

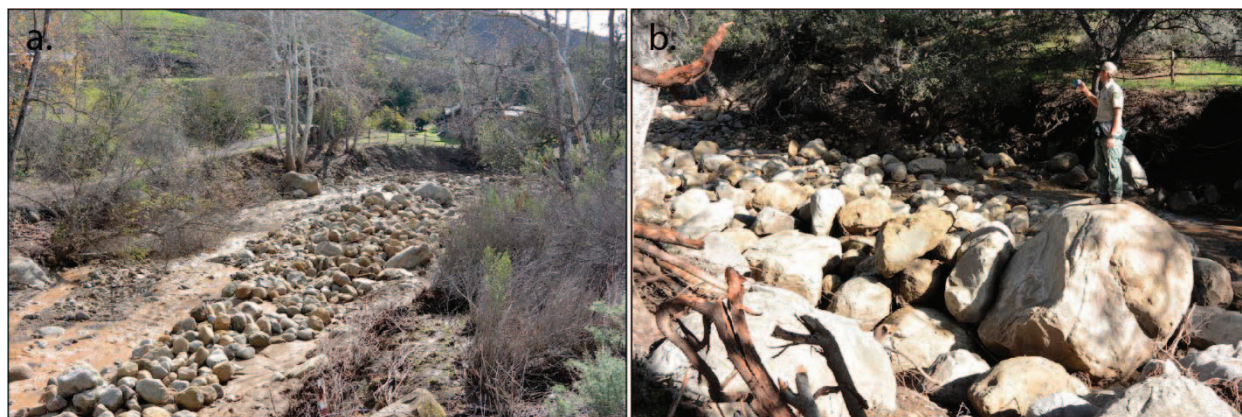
Field observations along the stretch of El Capitan Creek between the State Park boundary (upper end of the El Capitan Canyon Resort) and the Mid-Canyon Bridge (Figure 7) revealed that some segments of the stream experienced channel incision and scour depths ranging from 1.2 to 1.5 m. Other segments of the creek, mostly below the Mid-Canyon Bridge, accrued boulders and finer sediment deposition up to 4 m in depth. Lateral bank erosion occurred mostly on the outer banks at channel bends, exposing unsorted, non-stratified, matrix-supported alluvial channel and older debris flow deposits (Figure 8a). Since the field observation for this study began 24 January 2017 after the third consecutive rainstorm in a 4-day period (Figure 5), it is difficult to determine the exact time the scour and deposition took place along these segments of the stream channel. Along segments of the creek that experienced deposition, elongated boulder fields ranging in size from ~60 m to 140 m long, 10 m to 20 m wide were documented in the channel and were comprised of sub-angular to sub-rounded sandstone boulders ranging from 0.3 m to more than 2.5 m in diameter (Figure 9).

Figure 9. (a) Large elongated boulder fields that were deposited in the active channel. Boulder fields ranged in size from ~60 m to 140 m long and ~10 m to 20 m wide, and contained (b) sub-angular to sub-rounded sandstone boulders ranging in size from 0.3 m to more than 2.5 m in diameter.

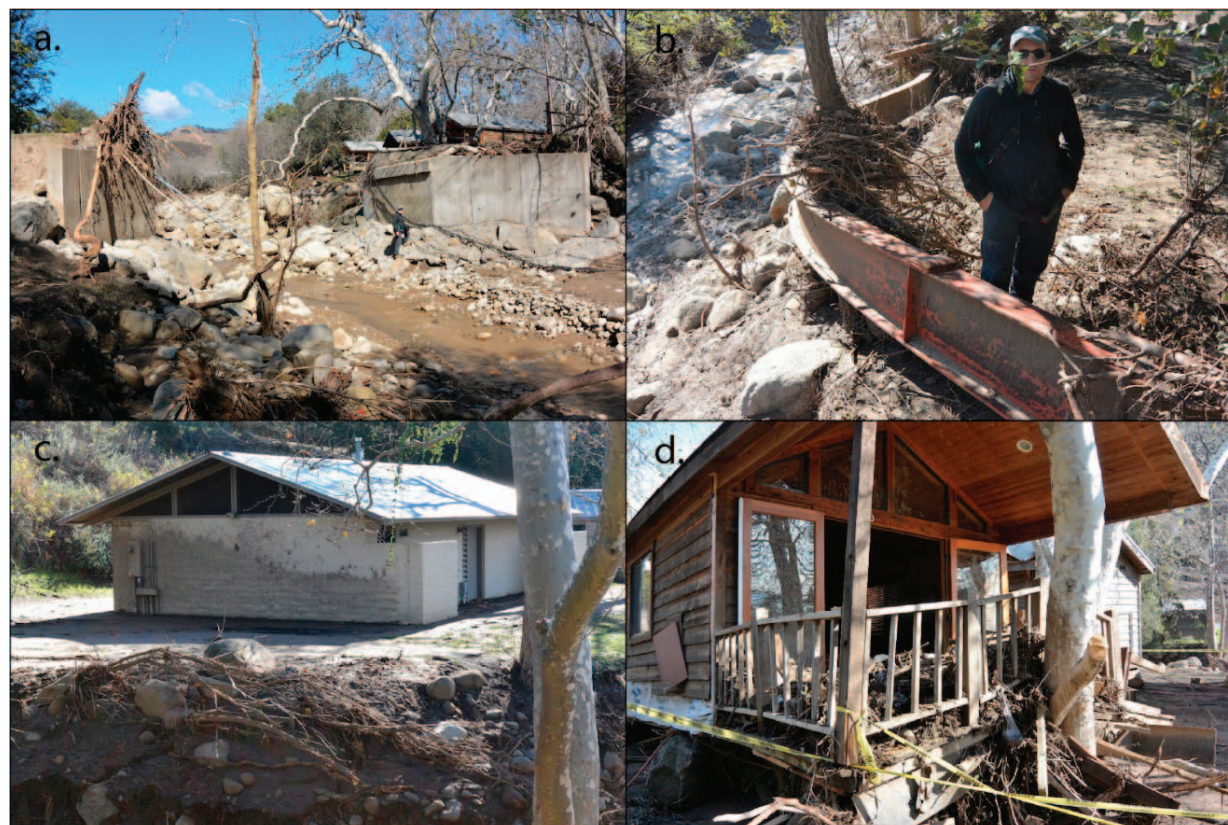
9:20 a.m. PST, about 13 minutes after the period of highest 15-minute rainfall intensity. Field evidence and eyewitness reports suggest the debris flow surge front included coarse woody debris that plugged foot and vehicle bridges, culverts, and the Hwy 101 underpass, similar to the 9 January 2018 Montecito debris flows that followed the 2017 Thomas Fire. This coarse woody debris included burned tree limbs and other vegetation transported down the creek from the upper portions of the watershed as well as riparian vegetation that survived the fire but was stripped and transported downstream by the powerful flooding and debris flow. The first bridge to be impacted by the debris flow was the Mid-Canyon Bridge, a large wood deck bridge, approximately 5 m wide and 15 m long. This bridge was supported on both sides of the creek by concrete abutments (Figure 10a). Attached to the top of these abutments and supporting a wooden deck were three metal I-beams 45.72 cm high, 19.05 cm wide, 0.95 cm thick, and 15 m long. The debris flow surge front demolished the bridge, knocking it off its abutments. The metal I-

beams were carried downstream and twisted around large standing trees (Figure 10b).

mud patinas to heights of up to 2.5 m above the bank-full discharge (Figure 10c). Similarly, along the channel bed, large oak and sycamore trees surviving the flow path were marked by mud patinas and scarring on their upstream side to heights of 2.5 m above bank-

levels of damage (Figure 10d). Nine cabins were forced off their foundations and swept downstream and as many as 21 vehicles were carried away and crushed, some reaching the ocean.

Figure 10. (a) Damage to the Mid-Canyon Bridge, supported on both sides of the creek by concrete abutments. (b) Twisted metal I-beams that supported the Mid-Canyon Bridge prior to the debris flow event. (c) Structure on the flood plain marked on its up-stream side by mud patinas to a height of up to 2.5 m. (d) Damaged cabins at the El Capitan Canyon Resort.
